OSA -0599-68

Subject: LOCAL MODIFICATION TO P/N DN55000 PARACHUTE

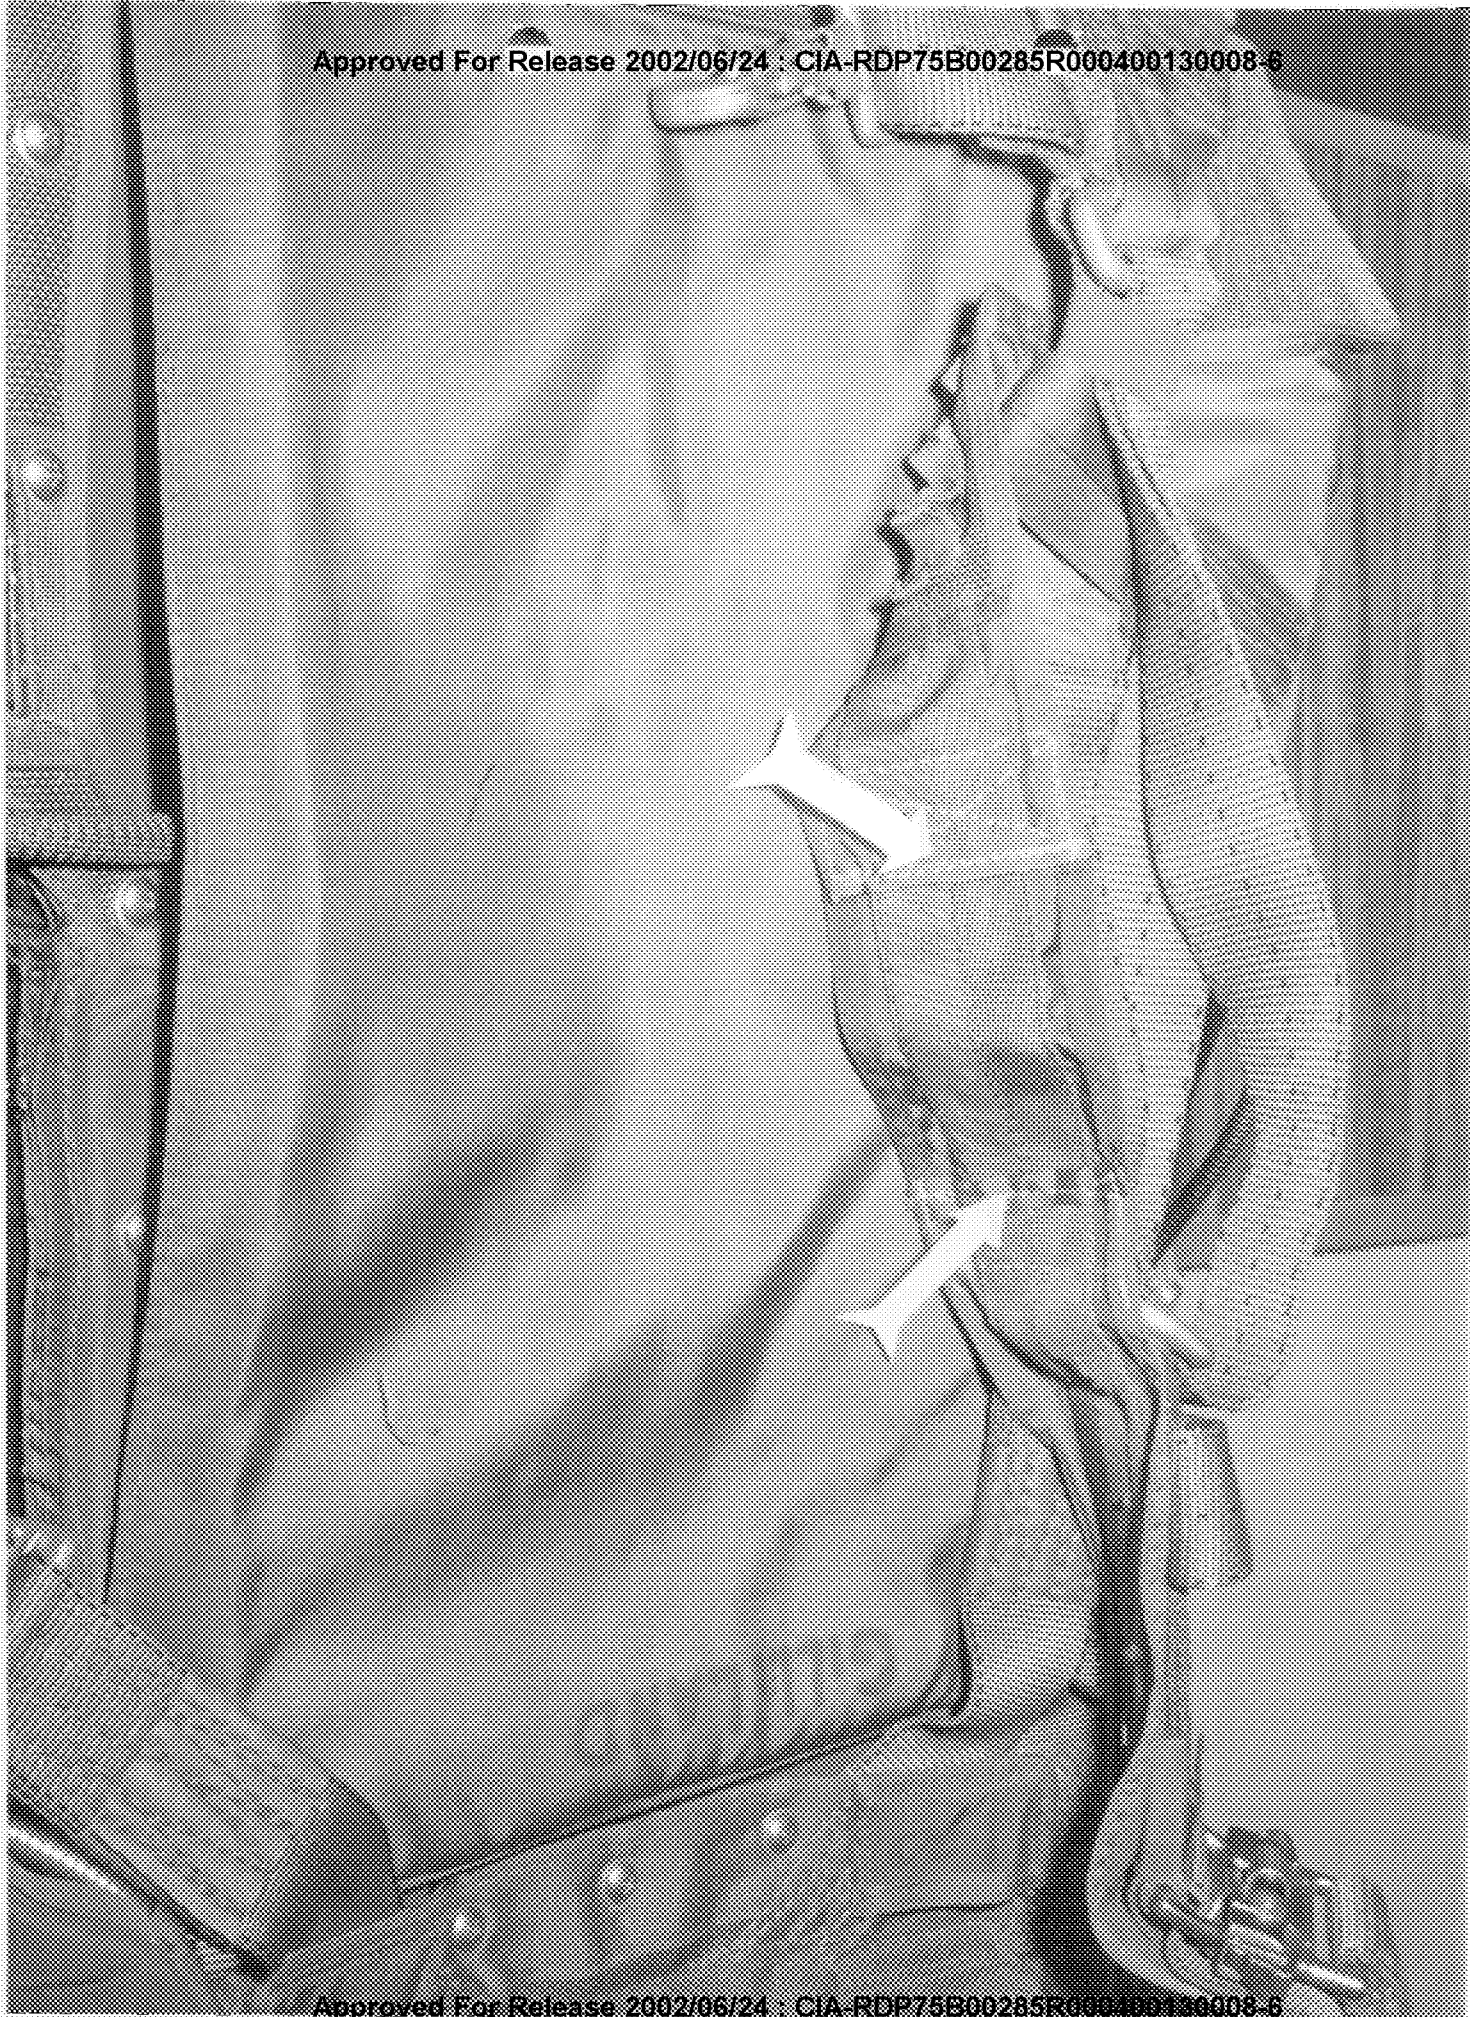
NEG. NO. 184/13

Enclosed photos show a modification incorporated to one DN55000 Parachute, by BW-4 personnel.

The modification consists of a four-inch extension to the non-structural fabric beneath the two vertical lift webs.

Prior to the modification, the fabric limited the harness length adjustment and put intolerable pressure on Bob's shoulders.
